TYPE B ACCIDENT  
INVESTIGATION BOARD  
REPORT OF THE  
DECEMBER 15, 1997, LEAKAGE  
OF WASTE CONTAINERS NEAR  
KINGMAN, ARIZONA

U.S. Department of Energy  
Fernald Environmental Management Project

# **Type B Accident Investigation Board Report of the December 15, 1997 Leakage of Waste Containers Near Kingman, Arizona**

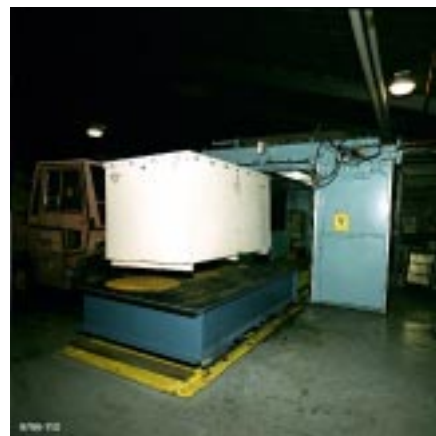
Figure 1-1 A Typical White Metal Box During Handling

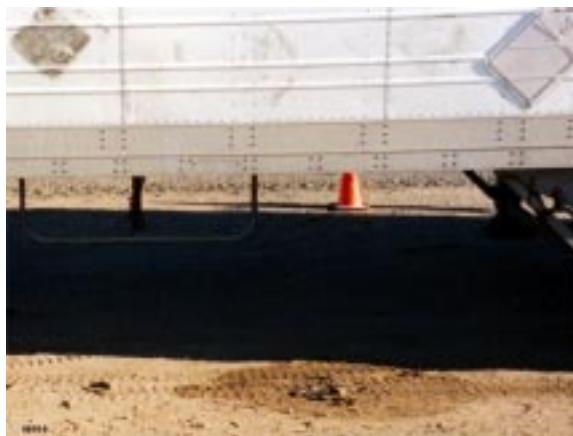
The event occurred as a shipment of seven White Metal Boxes containing low level radioactive waste was en route from FEMP to NTS. The truck driver identified the leakage of an unknown liquid from his trailer as he was preparing for a routine stop near Kingman, Arizona. There had been no observable leak at his previous inspection stop, approximately 370 miles before. He parked the truck adjacent to the Petro Truck Stop at Exit 66 of Interstate Highway 40 and notified FDF at 1654 Eastern Standard Time.<sup>4</sup>

Figure 2-1 The Leaking Trailer

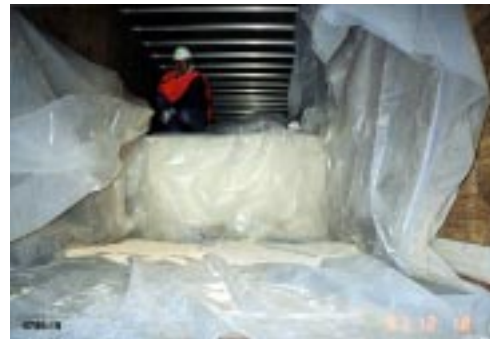
On December 17, 1997, after it was determined that there were additional leaks on the shipment, it was decided to employ an emergency response contractor and return the shipment to FEMP. A Pan Trailer (a trailer with a liquid tight inner lining) was requested from the Tri-State/Trism Motor Carrier on the afternoon of December 17. The containers that were still leaking were packaged in a plastic overwrap and loaded onto the Pan Trailer. The FEMP Support Team surveyed the original trailer bed and the White Metal Boxes for removable contamination and did not detect any release of radioactivity.

Figure 2.2 Leaking Containers Within a Plastic Overwrap

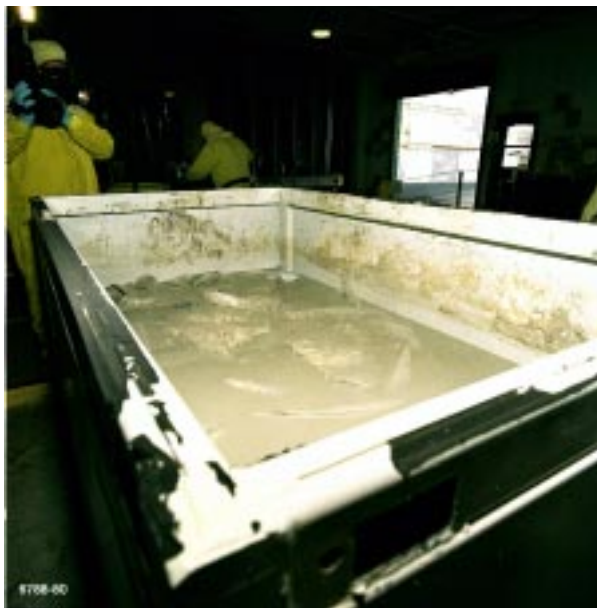
Figure 2-3 Box 483004 After Return to the FEMP

containers from the shipment showed no free liquid, Number 483004 showed evidence of liquid on top of the waste. Containers 483004 and 483141 were moved to Building 71 where they were opened. Visual examination confirmed that free liquid was present in Number 483004, but not Number 483141. The waste was removed from both boxes and placed into drums.

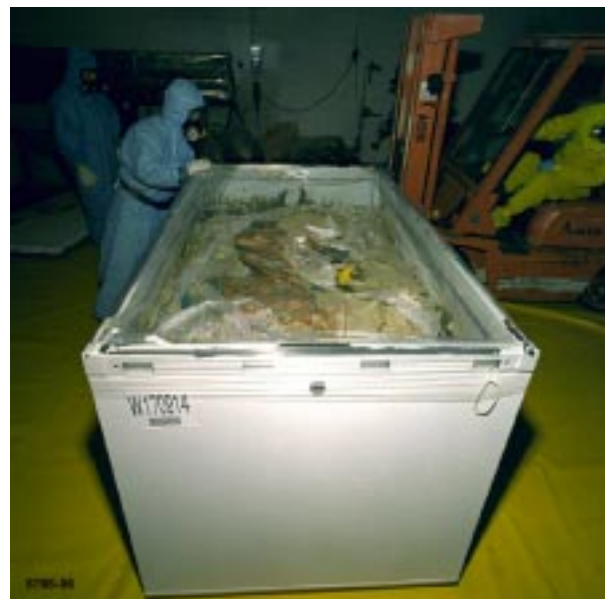
Figure 2-4 Box 483141 After Return to the FEMP

After unloading the waste, samples of both of the failed areas of container 483141 were removed. One was sent to the manufacturer for analysis. Later, the Board had the other failed area of 483141 sent to Sandia National Laboratories/New Mexico for independent analysis. The results from the analysis of the sample of 483141 provided to Sandia National Laboratories/New Mexico are discussed below. The results of the manufacturer's analysis of the other sample were unavailable in time to be evaluated by the Board.

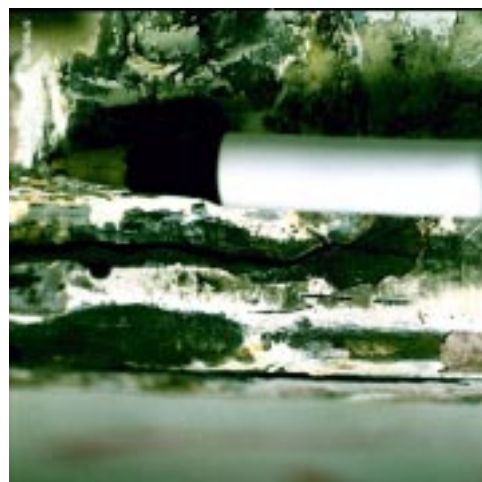
Figure 2-5 One of the Cracked Areas on Container 483141

- o The materials used to construct the container met the American Society of Testing and Materials chemical specifications, exhibited microstructures and hardnesses consistent with expectations, and exhibited sound welds. There was no evidence that materials or welding deficiencies were the primary cause of failure of the container.
- o The preponderance of evidence indicates that the primary crack resulted from combined bending and shear stresses that exceeded the yield and ultimate strength of the material, resulting in ductile overload failure.
- o Stress corrosion crack growth occurred subsequent to initial crack formation. This growth may have occurred during storage, transport, or both.
- o The vibrations and cyclic loads experienced during transportation caused the mating crack surfaces to repeatedly rub over one another,

resulting in wear and the effective widening of the crack to the point where leakage occurred.

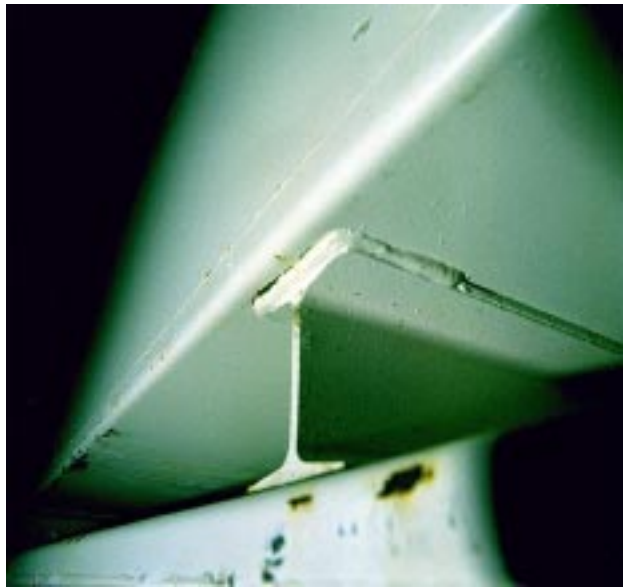
at FEMP) will cause yielding in the region around the end of the center runner (see Figure 2-6). The Sandia report goes on to state that adding a slight (2g) dynamic effect while stacking the top box is enough to cause failure.

Figure 2-6 Loaded Container Showing Indications of Paint Cracking

The Board examined a number of containers stacked and awaiting shipment at FEMP. Loaded waste containers stacked in Plant 6 were examined. These containers contain uranium materials awaiting shipment to British Nuclear Fuels, Limited. Many of these exhibited cracking and spalling of paint and inward displacement of the base plate at the end of the center runner. In addition, a number of loaded waste containers awaiting shipment to NTS were examined in Building 30A. Paint cracking and rust was visible in approximately 1/3 of these containers at the ends of the center runner. A typical observation is shown in Figure 2-6.

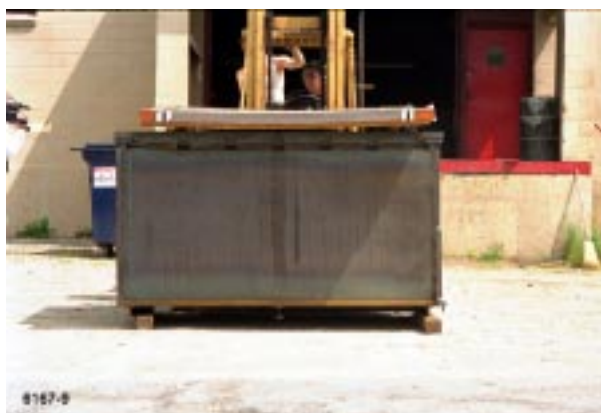
Figure 2-7 The Metal Container Tested

Request For Proposal. Pictures taken during the testing of the CGR samples show the runners flush with the side walls of the container (See Figures 2-7 and 2-8).

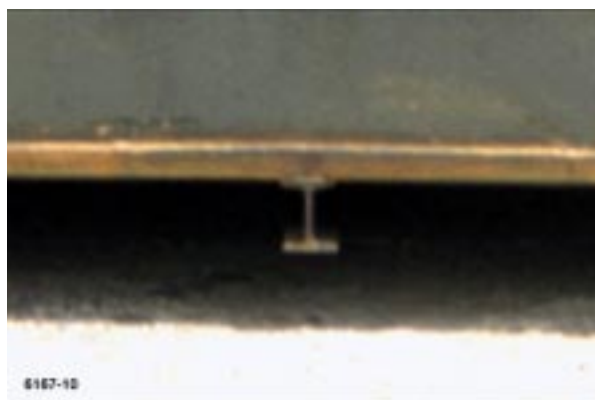
Figure 2-8 Closeup of Center Runner Area on the Metal Container Tested
